A hot spot for legionella

Investigation of a legionellosis outbreak in a welding workshop

Noelene O'Keefe—Department of Human Services Victoria

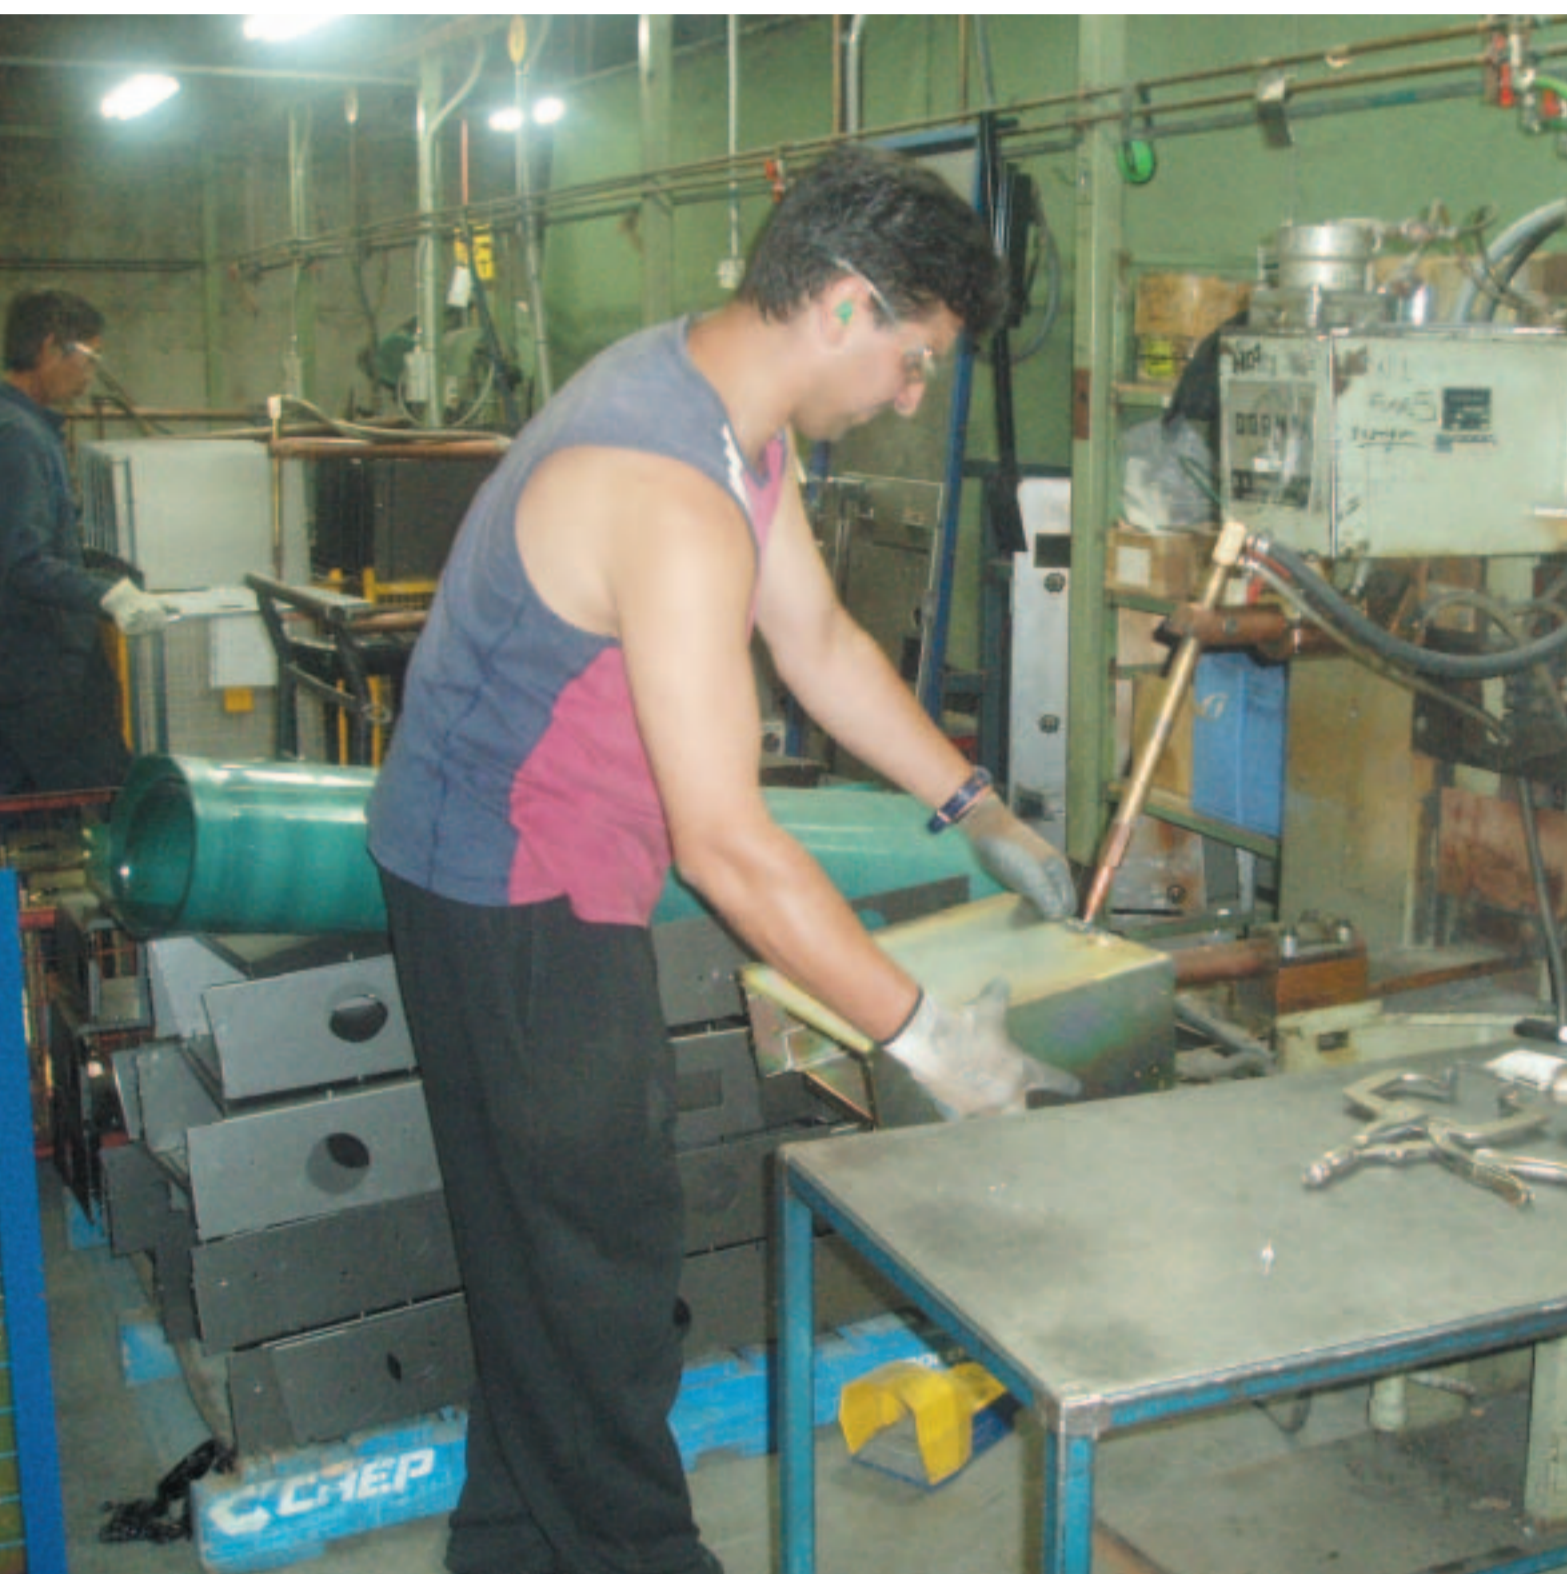
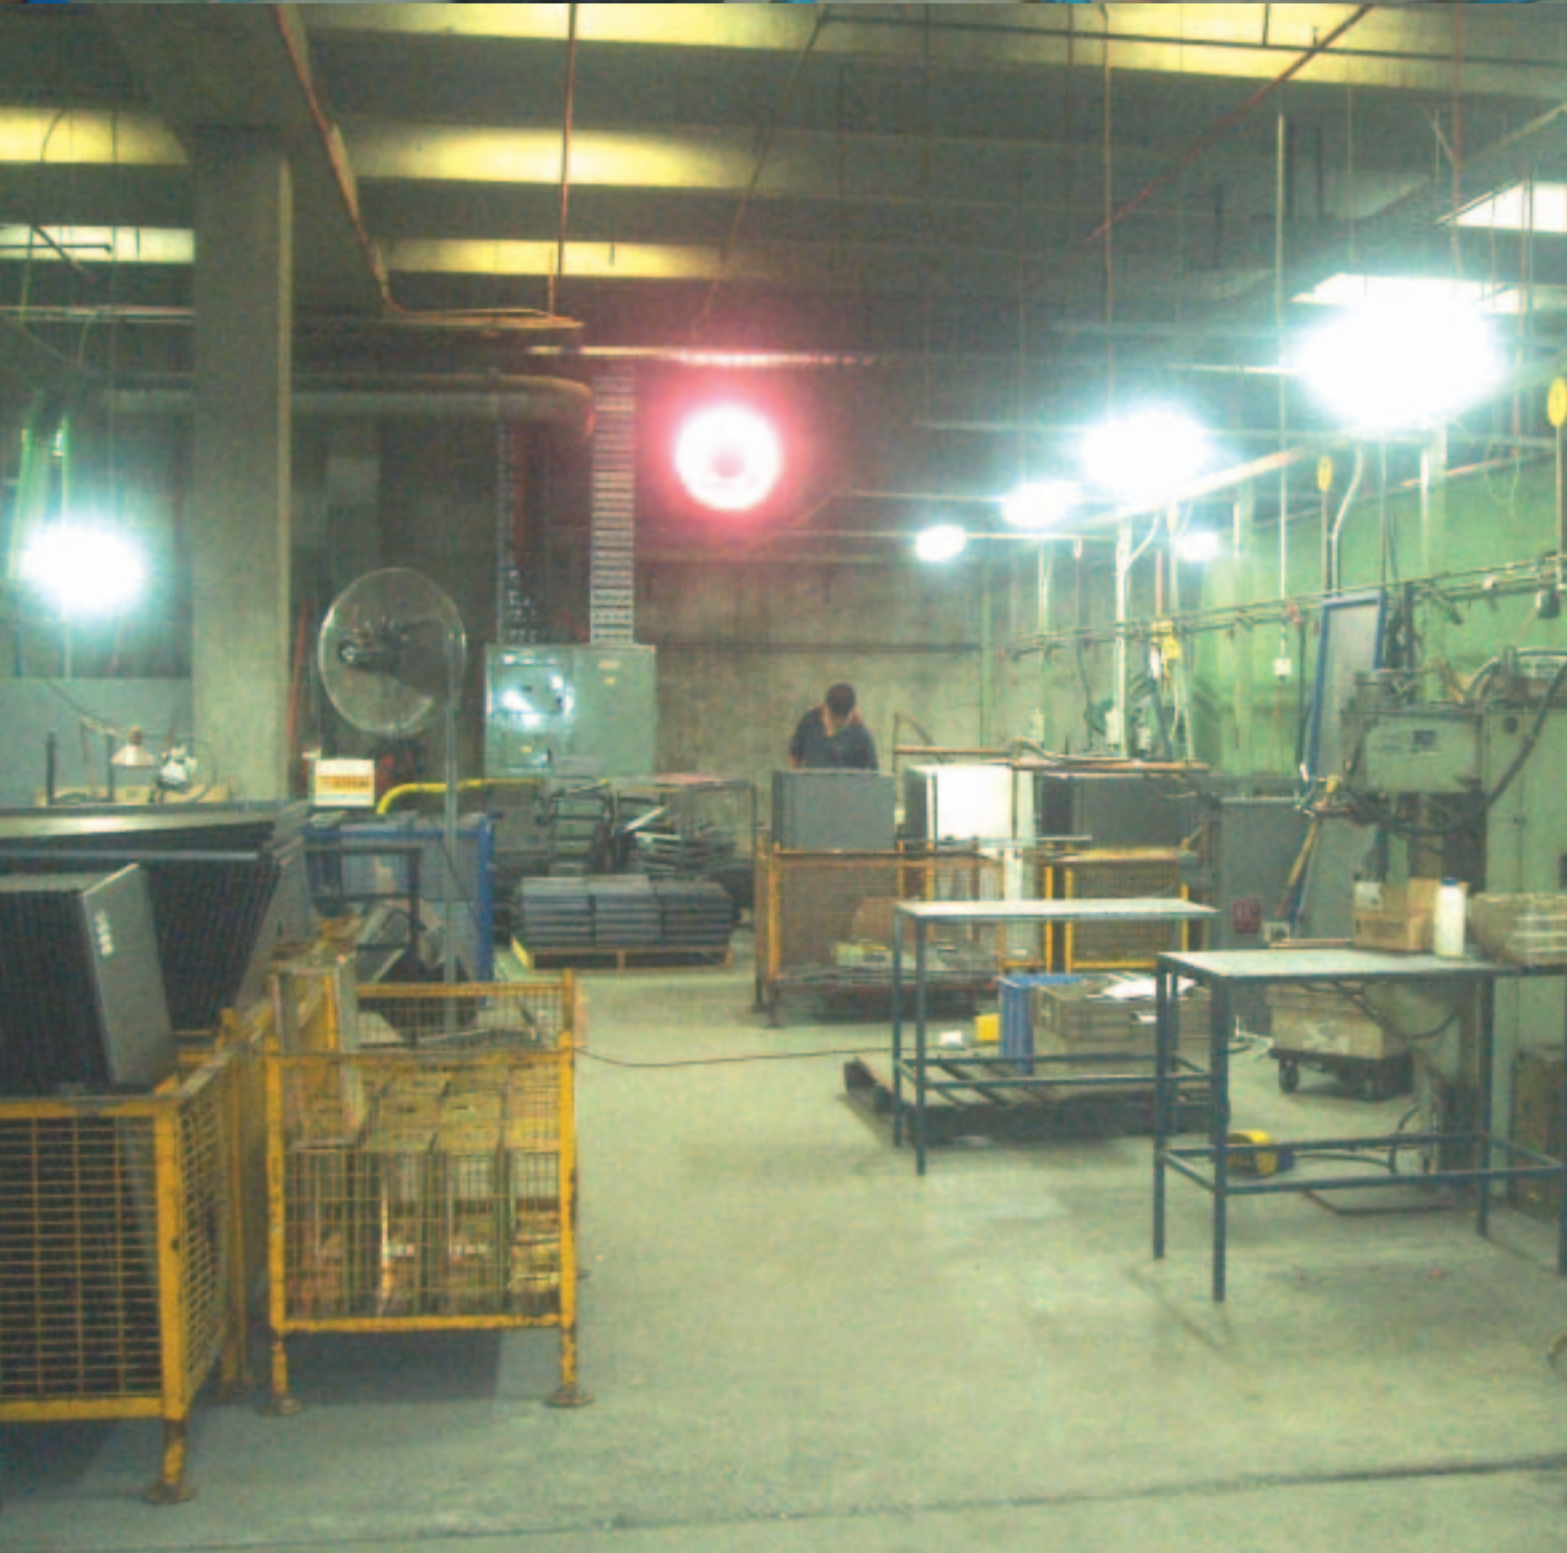
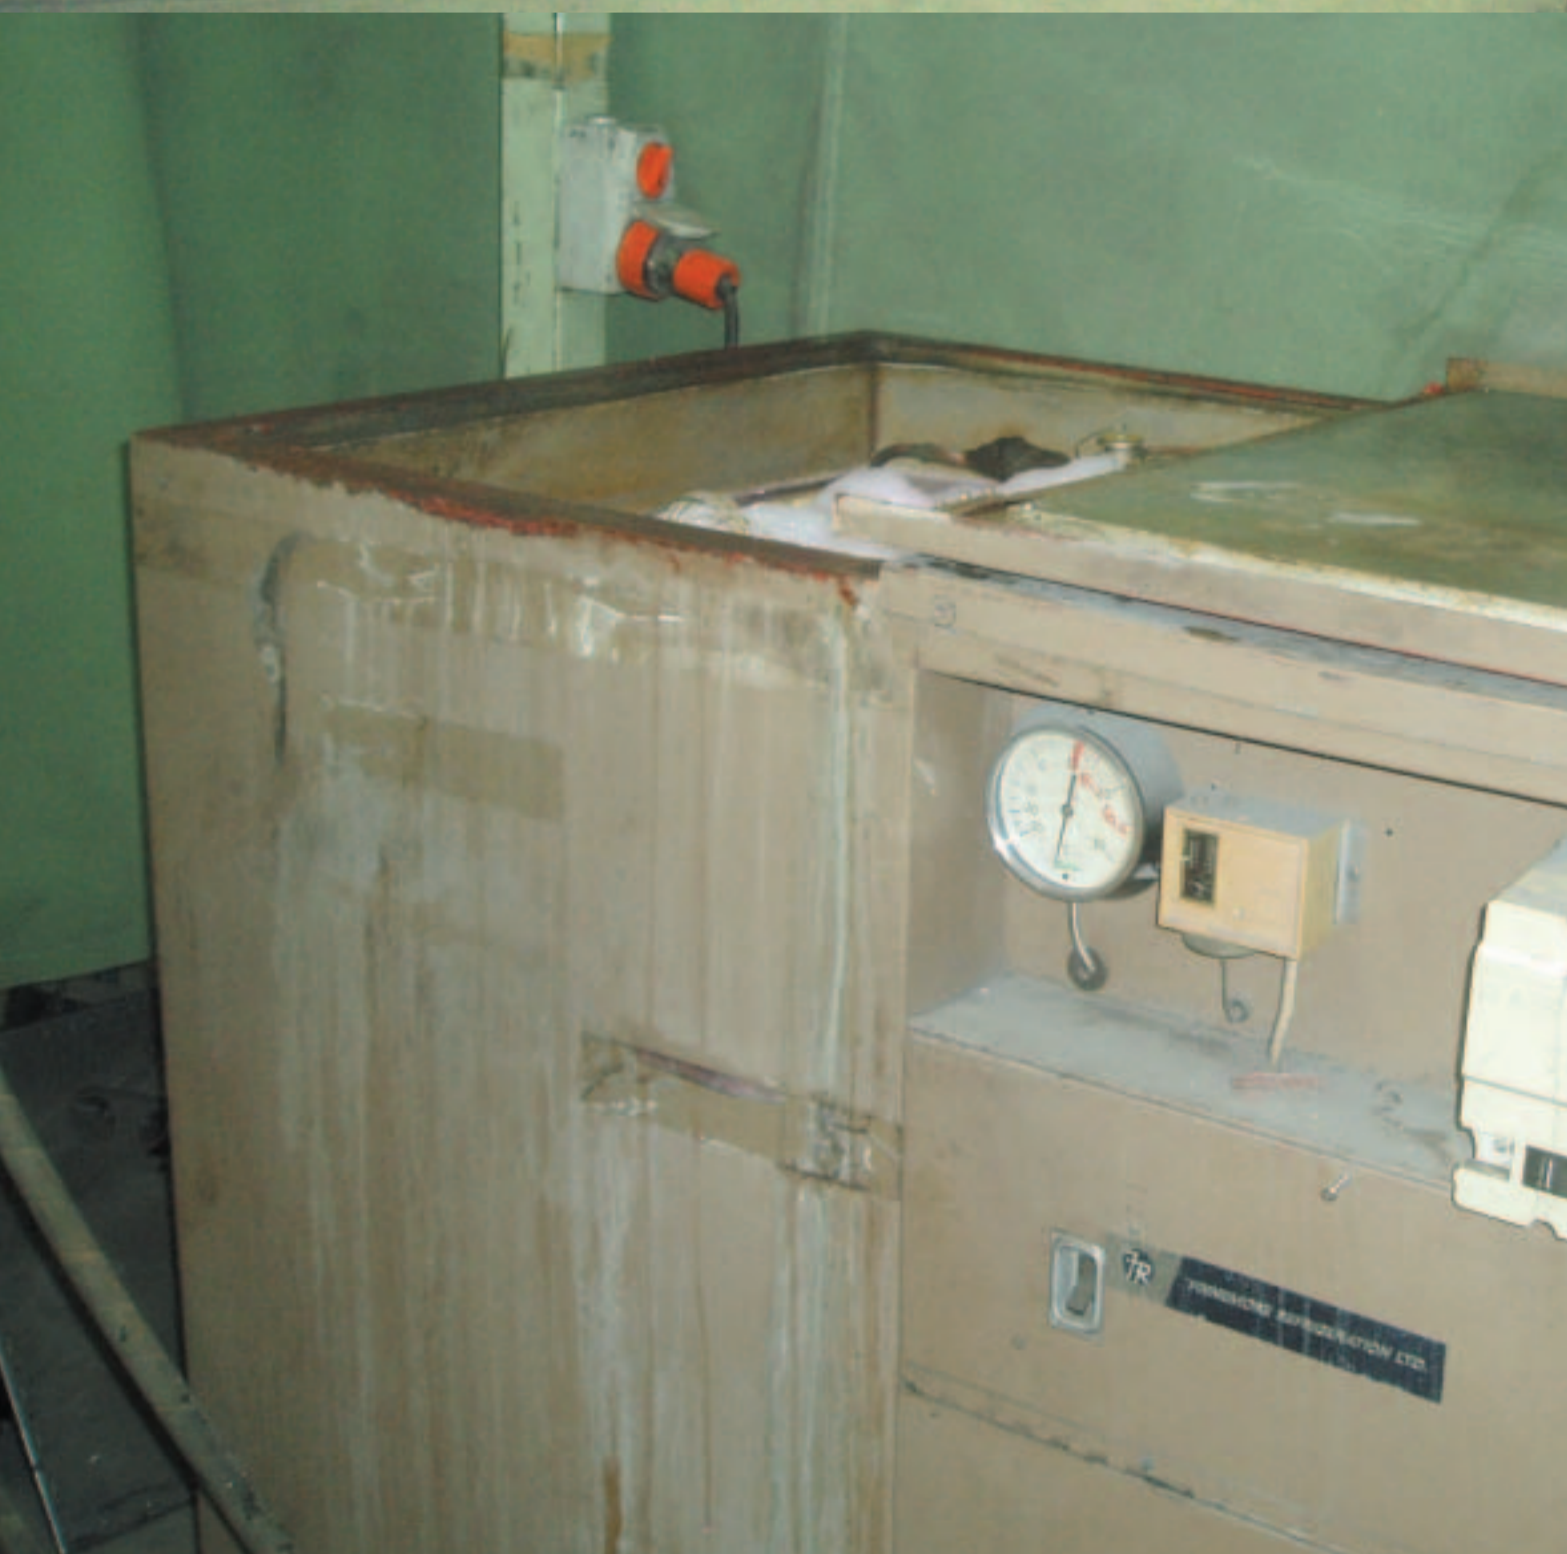
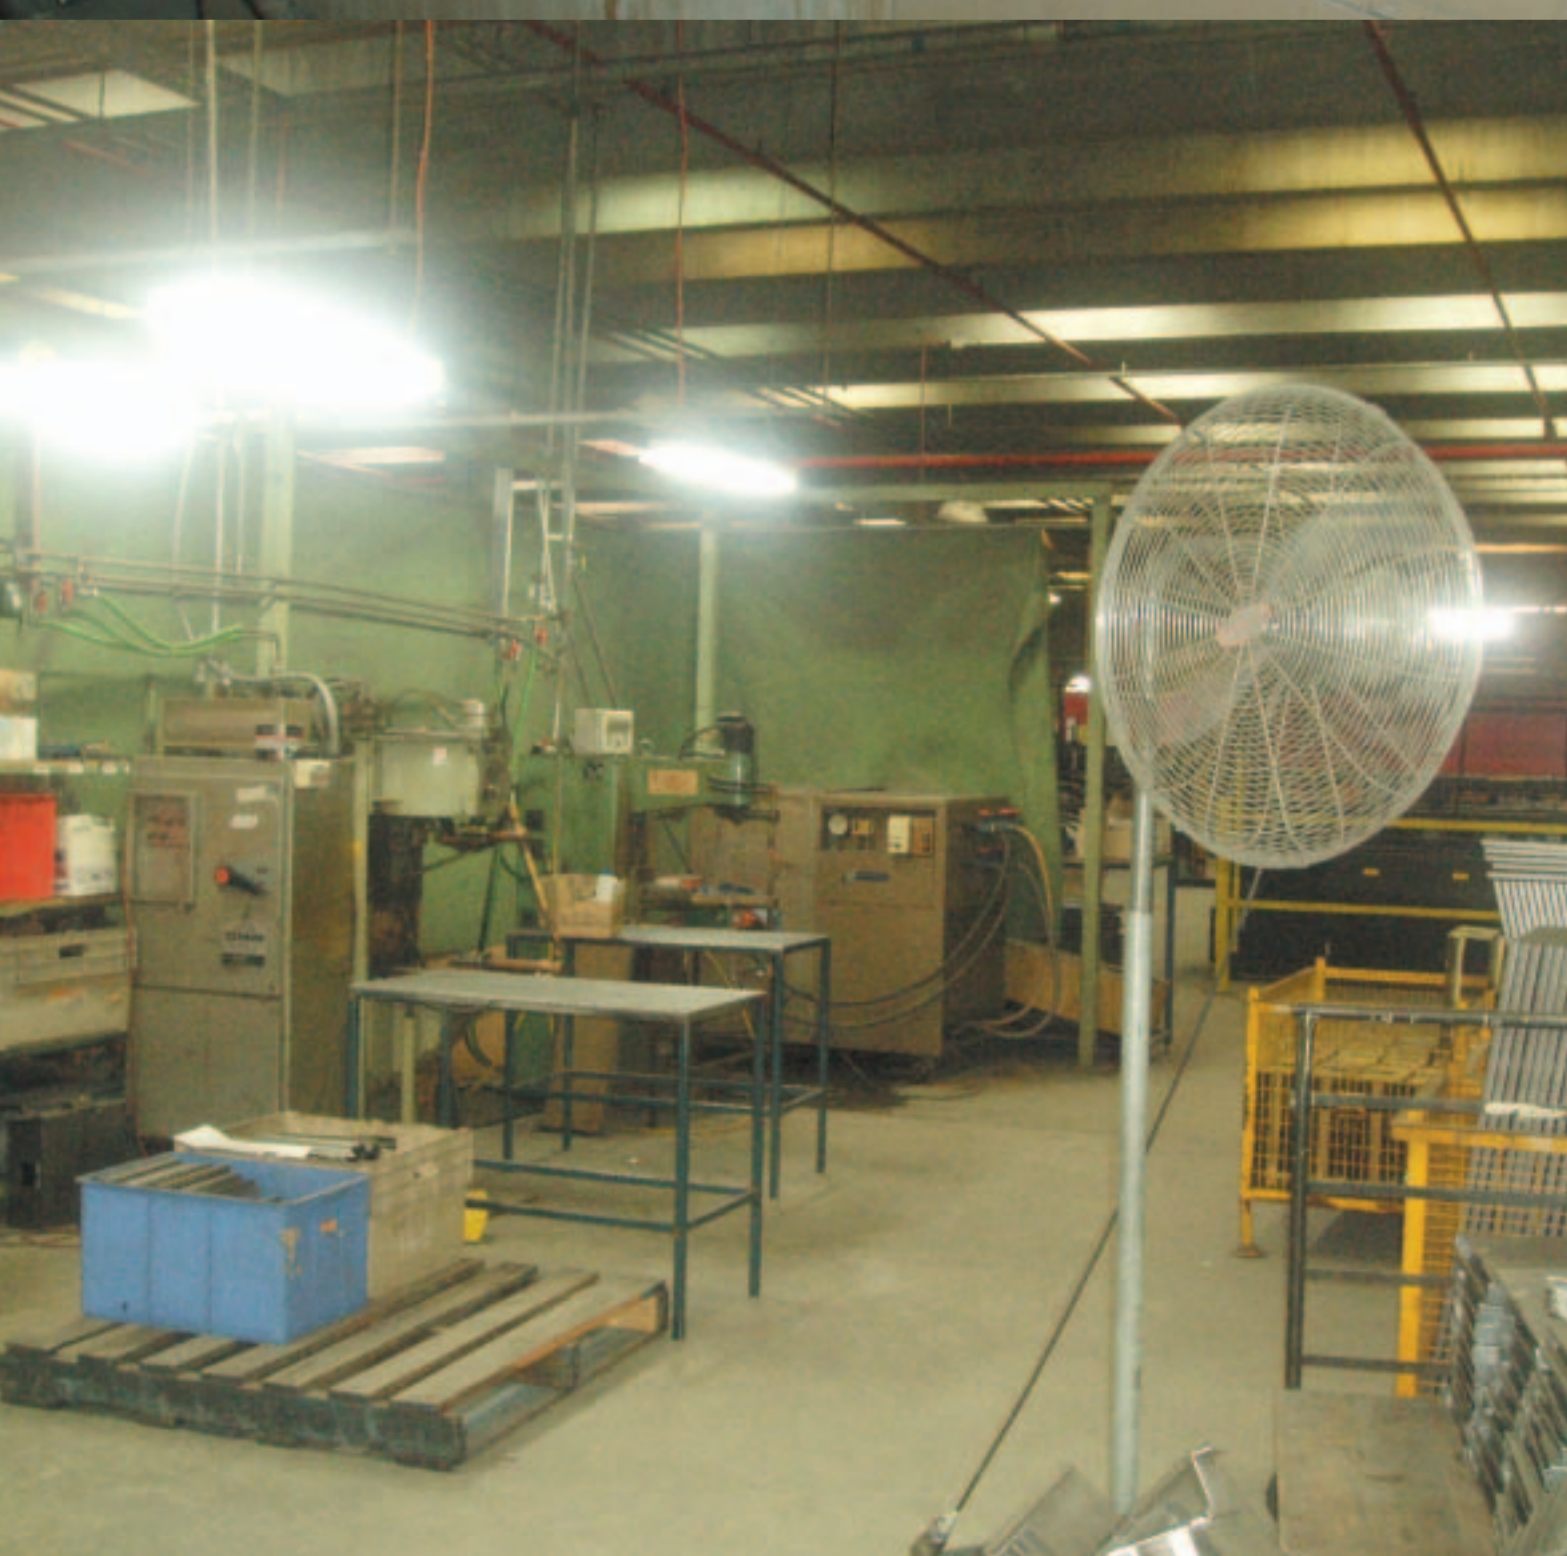
It was established that during the incubation periods of the cases, an industrial fan was placed next to the

heat exchange water bath to provide cooling for the two workers during hot weather. During this period the heat exchange bath lid was open.

Analysis of the water sample from the spot welding heat exchange bath yielded LP1 at 1300 cfu/ml. This strain was positive for MAB2 (Pontiac). Pulsed field gel electrophoresis (PFGE) subtyping conducted at the Microbiological Diagnostic Unit (MDU) at the University of Melbourne indicated that this was an unusual strain in Victoria. The MDU has not observed this strain since subtyping of human and environmental strains began in 1993.

Industrial heat exchange water baths should be kept clean with lids closed and should not have fans placed next to them to provide cooling for workers.
