A hot spot for legionella

Investigation of a legionellosis outbreak in a welding workshop

Noelene O'Keefe—Department of Human Services Victoria

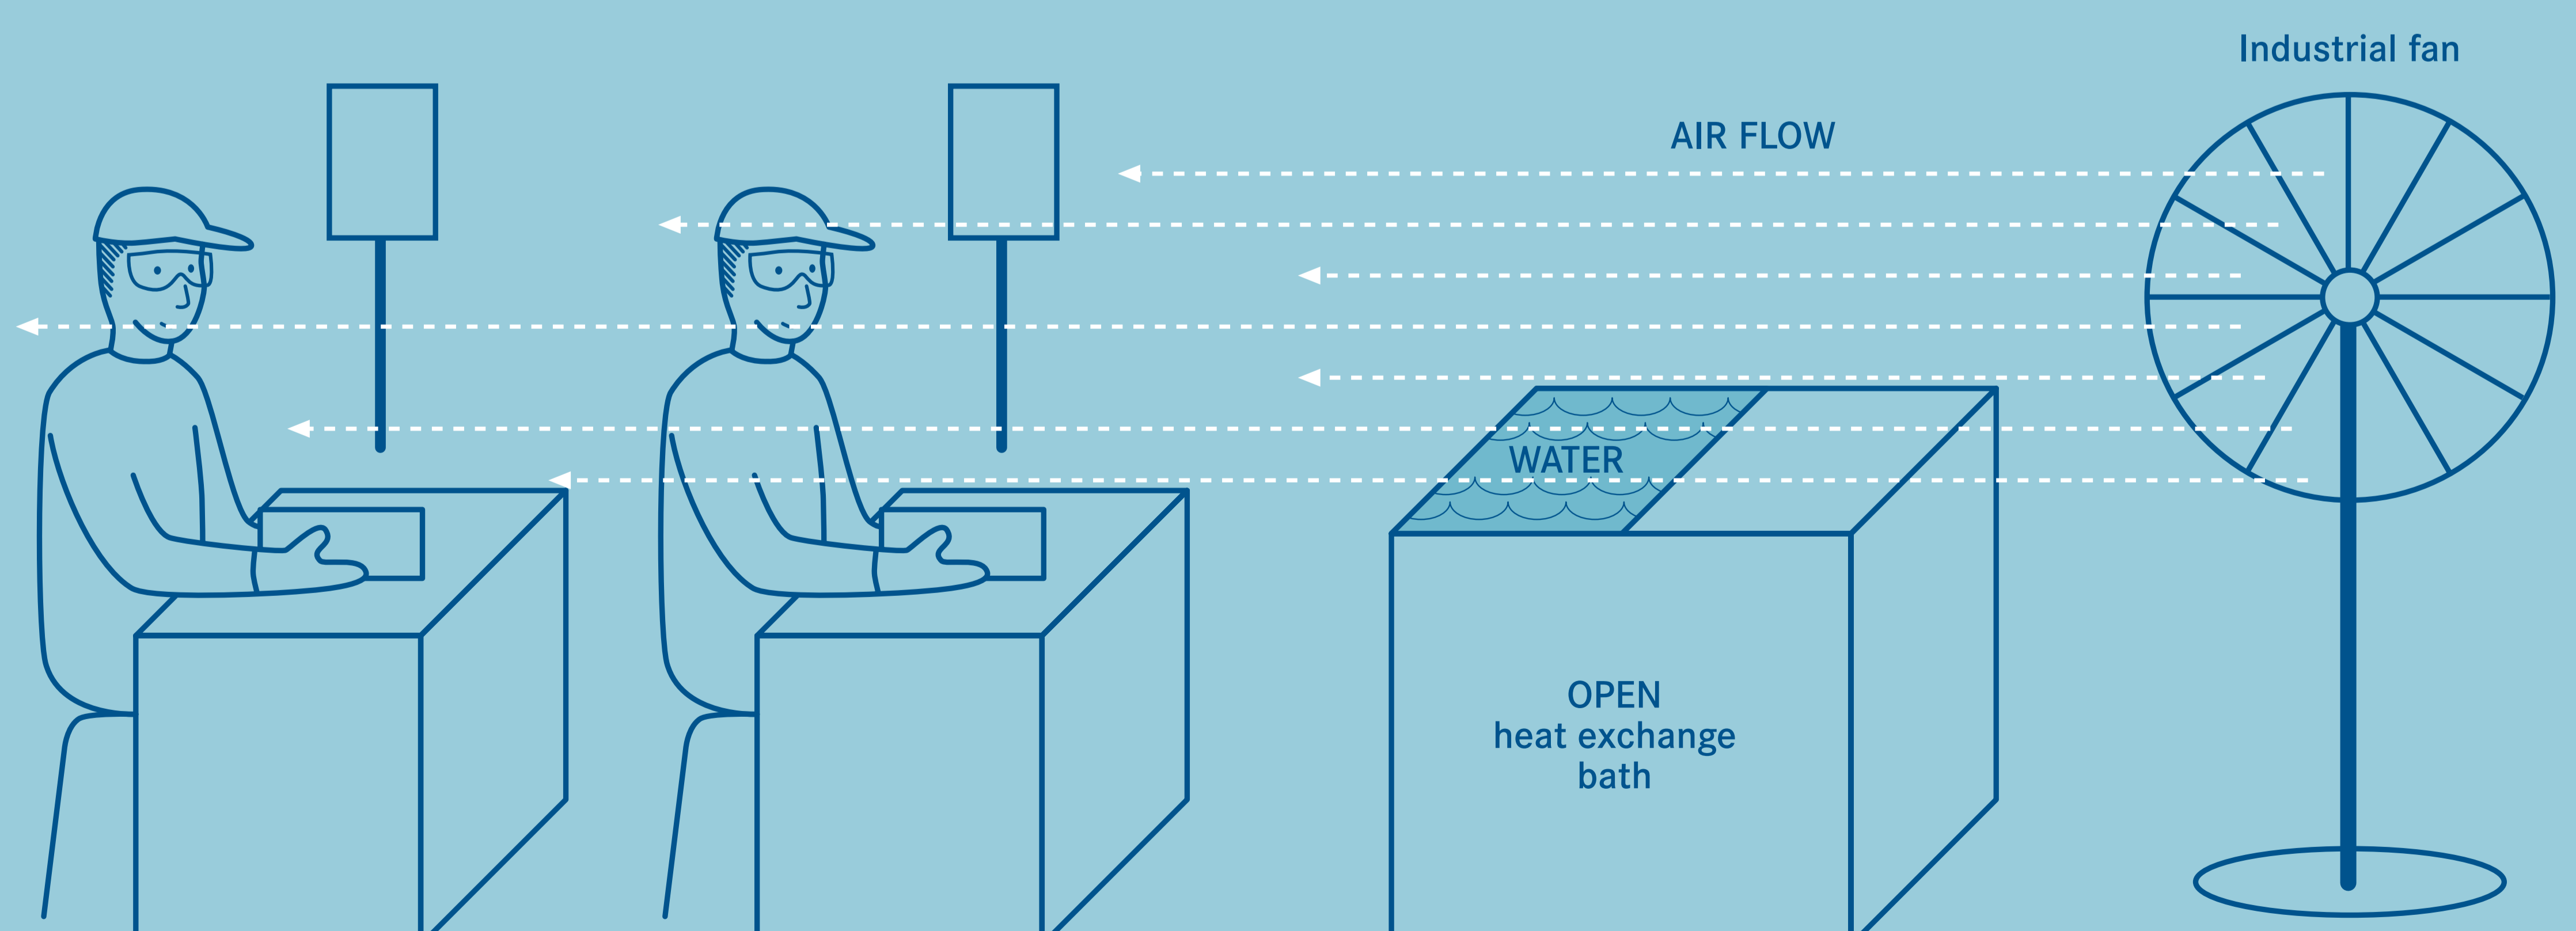
It was established that during the incubation periods of the cases, an industrial fan was placed next to the

heat exchange water bath to provide cooling for the two workers during hot weather. During this period the heat exchange bath lid was open.

Analysis of the water sample from the spot welding heat exchange bath yielded LP1 at 1300 cfu/ml. This strain was positive for MAB2 (Pontiac). Pulsed field gel electrophoresis (PFGE) subtyping conducted at the Microbiological Diagnostic Unit (MDU) at the University of Melbourne indicated that this was an unusual strain in Victoria. The MDU has not observed this strain since subtyping of human and environmental strains began in 1993.

Industrial spot welding baths may be a previously under-recognised source of *Legionella pneumophila* infection.

Industrial heat exchange water baths should be kept clean with lids closed and should not have fans placed next to them to provide cooling for workers.
